# **Geohazard Assessment of Lands**

235 QUARRY DRIVE, SALT SPRING ISLAND

# **Report for Coastal Erosion Mitigation**

Developed by: Thomas R Elliot PhD P.Geo P.Ag TRE Environmental Services tom@elliot.org

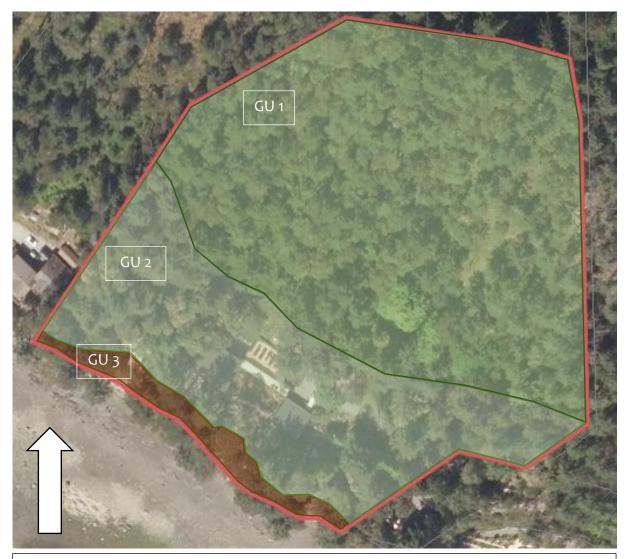
**Figure 2** – Geohazard Units of self-similar terrain, labelled with hazard rating. Note that GU 2 (Very Low hazard) would receive and settle mobilized material from GU 1 (Low-Moderate hazard). GU 3 (High hazard) will see continued erosion geohazard until motivating factors are mitigated.

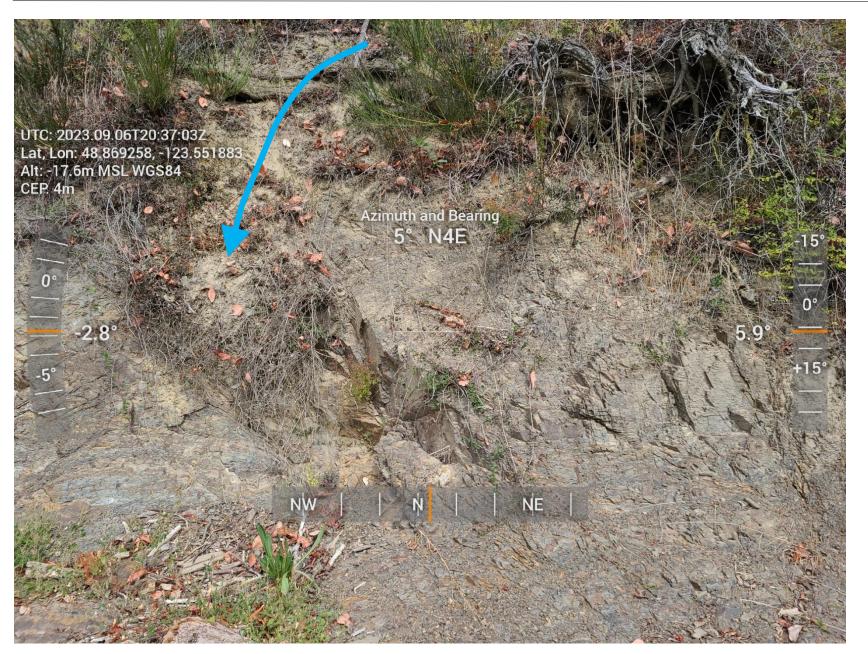
235 Quarry Drive: Progressive sloughing of surficial soil, driven by stormwater seepage. Minor toe erosion of friable bedrock present at this location.

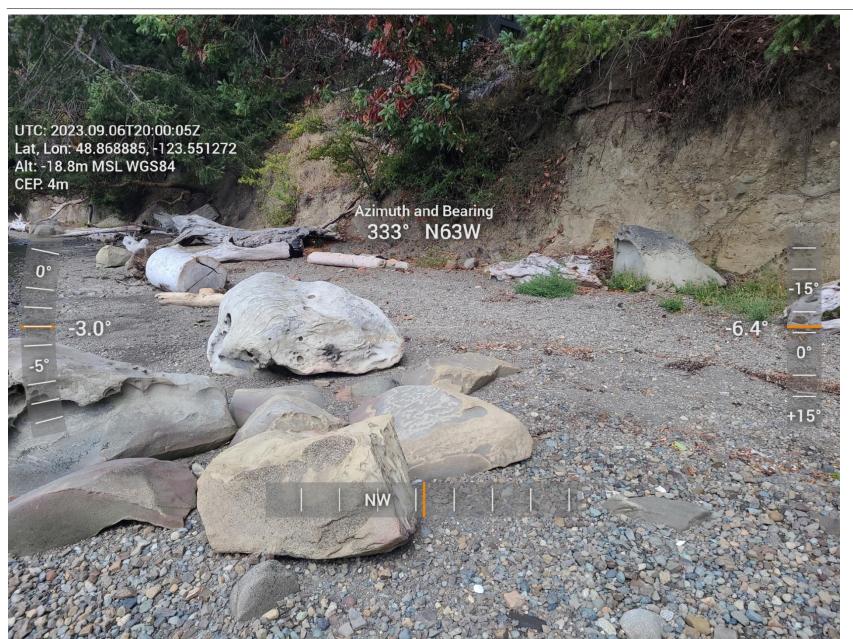
434 Baker Road: Background: surficial soil vulnerable to wave erosion rising from bedrock. Undercut root-masses overhanging. Foreground: Presence of a natural 'rock cluster', which has been recommended to be reproduced during the proposed beach nourishment program.
