# **Geohazard Assessment of Lands**

235 QUARRY DRIVE, SALT SPRING ISLAND

# **Report for Coastal Erosion Mitigation**

Developed by: Thomas R Elliot PhD P.Geo P.Ag TRE Environmental Services tom@elliot.org

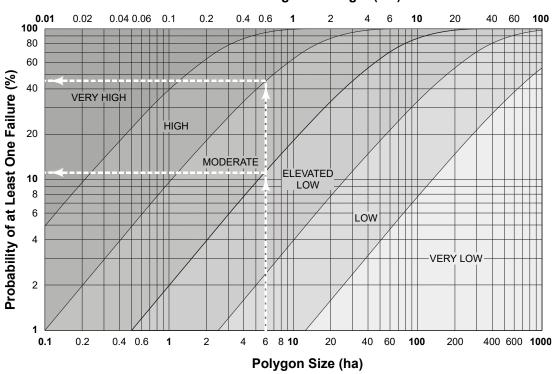
Figure II\_1 – Probability of at least one failure based on a geohazard unit (GU) assessment area size or road length. This figure has been adopted from BC Forestry practices and is based on a single forestry harvest cycle, typically lasting 60 years within Coastal BC.

Figure II\_1 has an example sketched with dashed white lines. The example indicates probability of failure for a **6** ha geohazard unit area with a **moderate** hazard rating. The probability of at least one failure occurring within the assessed geohazard unit area over the period of one forestry harvest cycle is between ~12 – 45%.

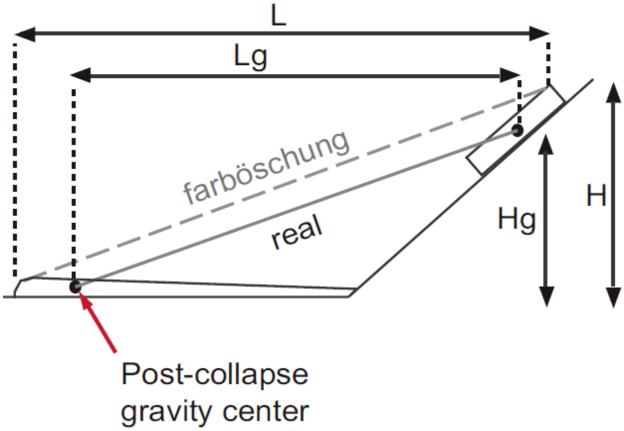
**Figure II\_B** – Farböschung angle functionality for sliding masses on a slope. The specific mathematics of which are not supplied here for brevity.

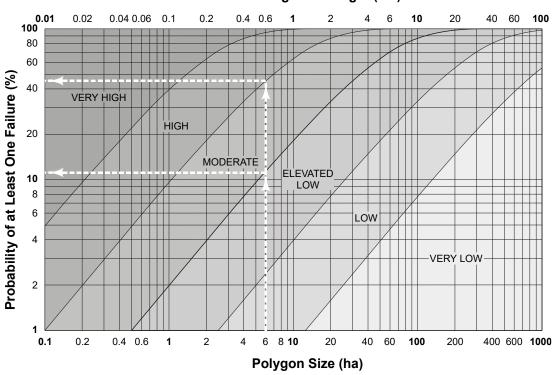
Figure II\_1 – Probability of at least one failure based on a geohazard unit (GU) assessment area size or road length. This figure has been adopted from BC Forestry practices and is based on a single forestry harvest cycle, typically lasting 60 years within Coastal BC.

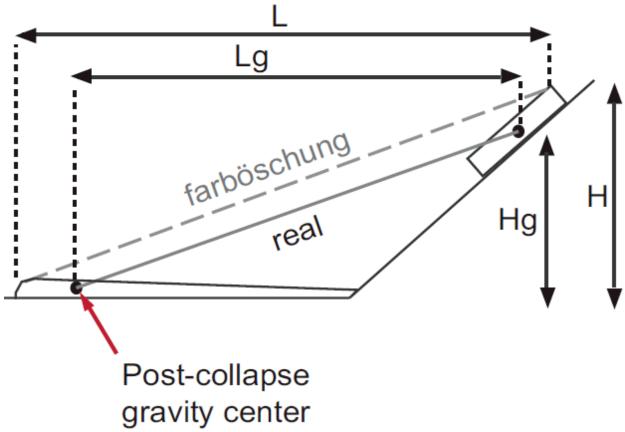
**Figure II\_B** – Farböschung angle functionality for sliding masses on a slope. The specific mathematics of which are not supplied here for brevity.

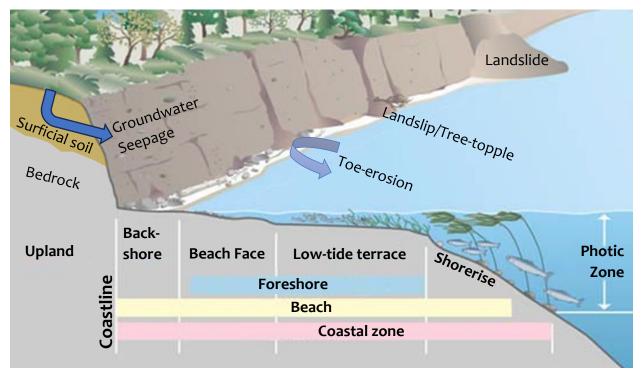
FIGURE 2. CONTEXTUAL DELINEATION OF THE SITE WITH RELEVANT TERMINOLOGY TO ASSIST WITH READING OF THIS REPORT. THE COMPONENTS OF THE COASTAL ZONE AND UPLANDS ARE INDICATED ALONG WITH ACTIVE EROSION MECHANISMS. ADAPTED FROM: <u>KING</u> <u>COUNTY NEARSHORE ENVIRONMENTS</u>, CENTRAL PUGET SOUND, WASHINGTON STATE.

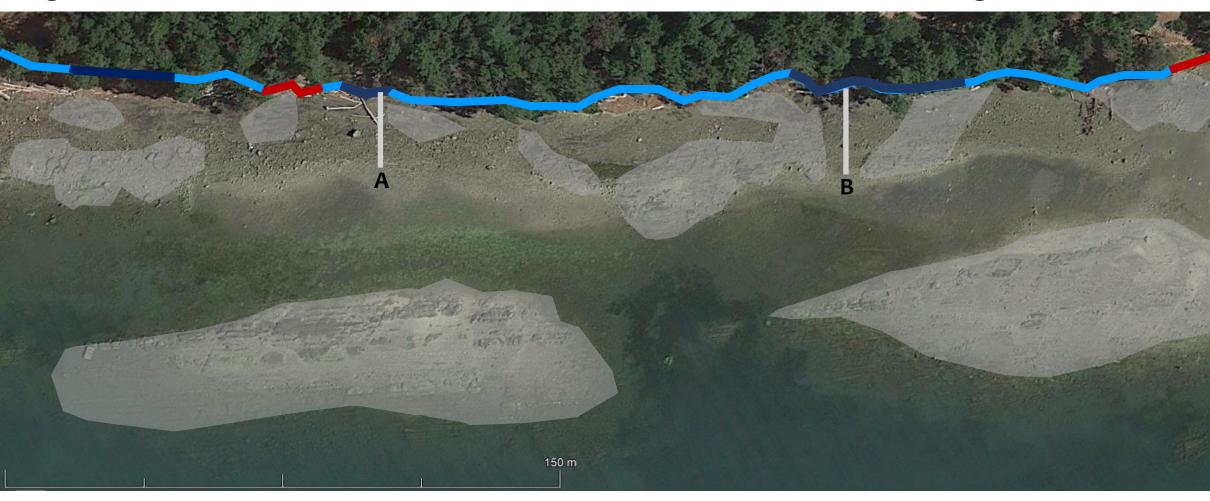
# Figure 3. Shoreline types, sediment transects and bedrock outcroppings

Within the low-tide terrace there is a mixture of sediment and bedrock coverage, as shown in Figures 3 & 4 – Appendix A. The accumulation of sediment is facilitated by undulating bedrock surface, with depressions readily infilled. The infill presented cobbles and gravel surface armouring, with fine sediments captured and retained underneath. There is a typical progressive reduction in the amount of mobile gravel toward the seaward extent of low-tide terrace.

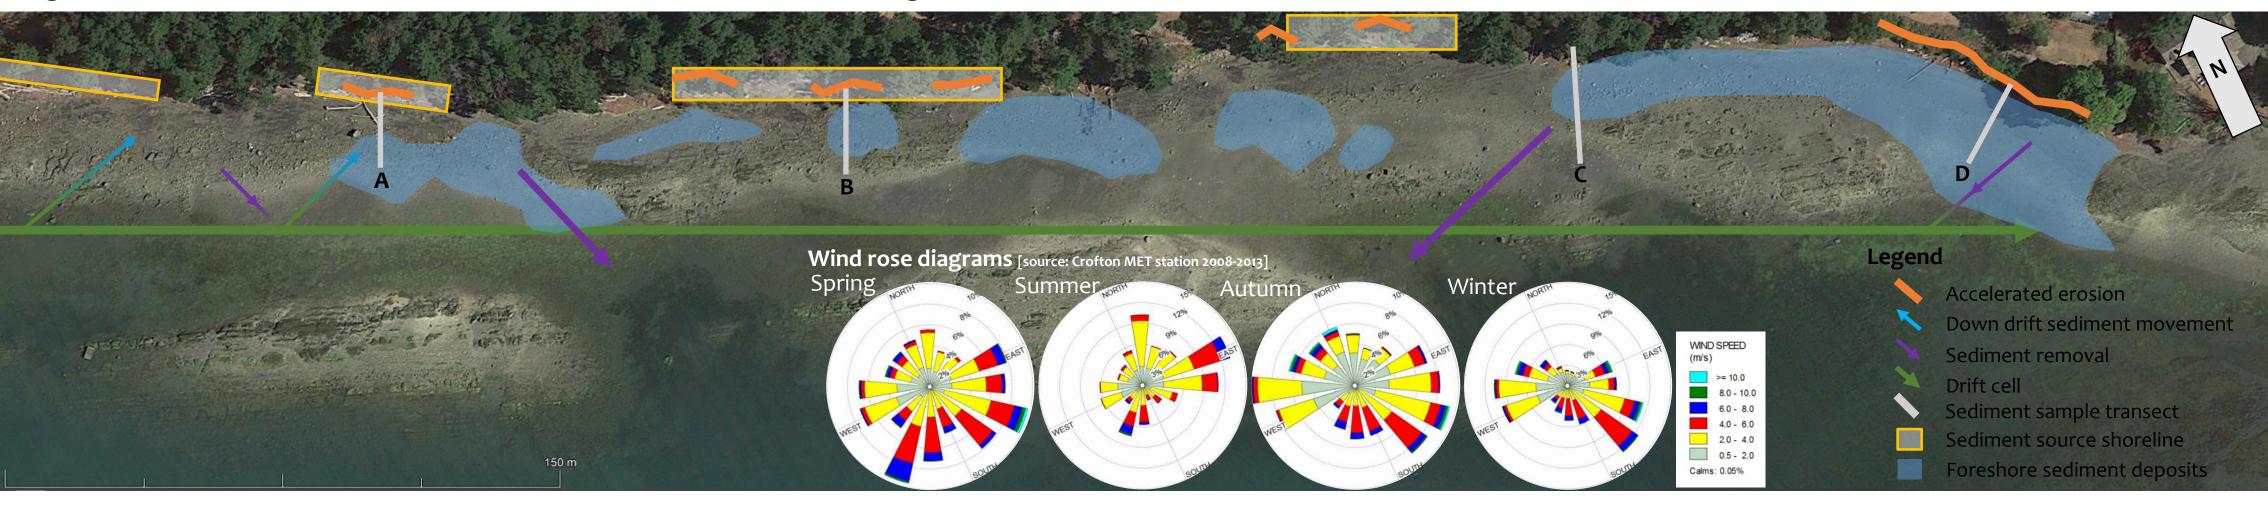
# Figure 4. Sediment dynamics, drift-cell current, and windrose diagrams

Wind-driven wave generation is largest in the west to northwest direction, creating acute incidence of approach. However, windrose diagrams (Figure 4) demonstrate a predominantly southwest to southeast winds that reach moderate velocity ( $\geq$ 6.0m/s). These predominant

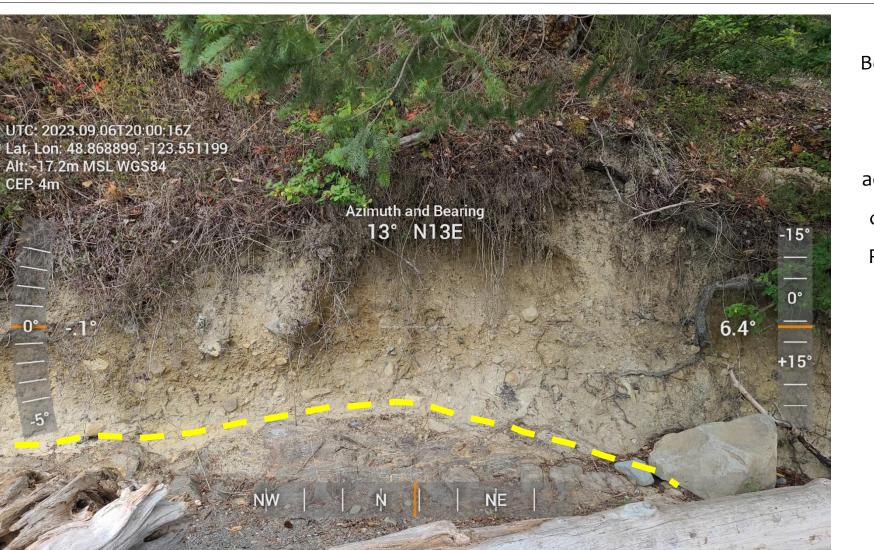
235 Quarry Drive: Progressive sloughing of surficial soil, driven by stormwater seepage. Minor toe erosion of friable bedrock present at this location.

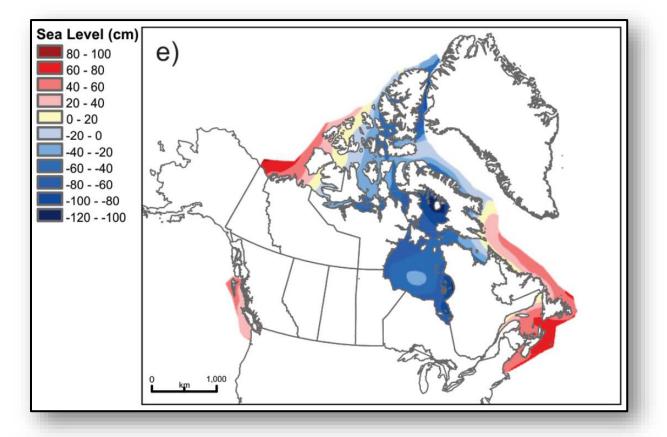
**Figure 1.** [ABOVE] Relative sea level change for coastal environments of Canada in year 2100 under RCP4.5 (median values).<sup>1</sup>

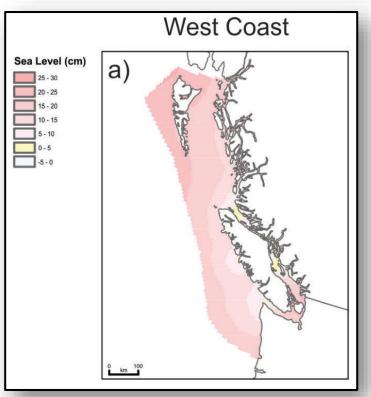
**Figure 2.** [LEFT] Relative sea level rise in year 2050 under RCP8.5 (high values) for the Juan de Fuca and Georgia Straight, and continuing north along coastal British Columbia.<sup>1</sup>

The discretized mapping shown in Figure 2 demonstrates a 0.20m increase in relative sea level in year 2050 under RCP8.5. Increase in sea level results in more depth of water further up on the backshore where average existing sea level does not reach unless under storm surge. As such, any increase in average existing sea level for an area currently not covered will result in a proportional increase of wave-energy. For example, in year 2050 a 0.20m increase will result in up to a 20% increase in transport energy, resulting in a coarsened sediment distribution across size-ranges, which should be considered when determining beach nourishment sediment size.

However, since beach nourishment requires replenishment at periodic intervals that are dependent on the beach sediment cell and alongshore and evacuation transport, the estimated sea level change in a shorter time-frame should be considered. Figure 2, presenting year 2050 under RCP8.5 should be considered for size-scaling of existing sediment for the beach nourishment sediment size distribution.

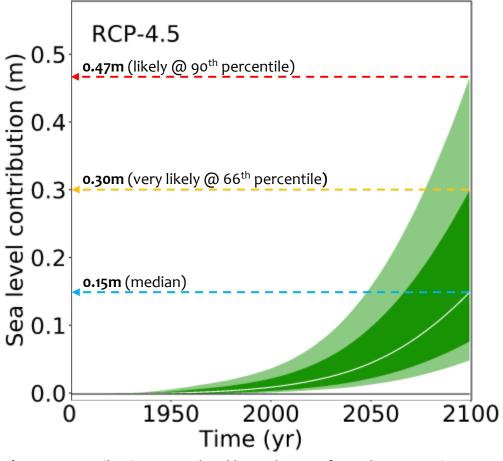
The estimated rate of additional sea level rise contributed by melt of Antarctica ice sheets is shown in Figure 3 below, with the maximum value being extracted to demonstrate a precautionary principle when determining DSL.

**Figure 3.** Contribution to sea level by meltwater from the Antarctica ice sheet, as determined in LARMIP-2 modeling<sup>2</sup>.

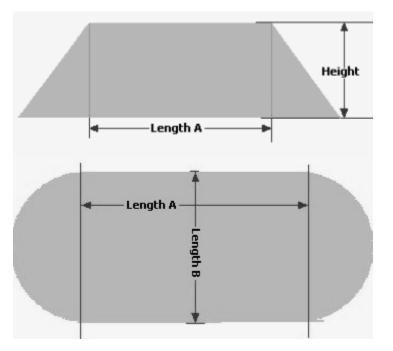
Calculation of the loaf volume is based on the following schematic:

This results in approximately 770m<sup>3</sup> (~1,000 yards) of aggregate material required for the recommended beach nourishment segments on Baker Beach.

Basing this calculation on a cumulative ~300m of shoreline recommended to receive beach nourishment, the placement of aggregate to a height above the DSL will ensure entrainment and re-distribution by natural forces in the recommended areas of Baker Beach. Initial placement will be 'loaf' shaped to a height of 1.00m above existing grade, with an average width of 5m to encompass the transition from backshore beach and foreshore beach face.
